**Bill & Sue Ashenart**  
**S/V SWALLOW**  
**Houston, Texas**  
**713-252-0409**  
**FUJI 35 - #061**  
**USCG Doc No: 593978**  
**Email : [bill@ashenart.com](mailto:bill@ashenart.com)**

*Swallow* is from the board of Niels Helleberg at the historic John G Alden Yacht design firm. She is a classic full keel, 35 foot on deck, ketch rig with a beautiful lines that can be identified as an Alden design by anyone who sees her. She was born in 1974 as Hull # 061 in the Fuji Yacht Builders yard in Yokosuka Japan.

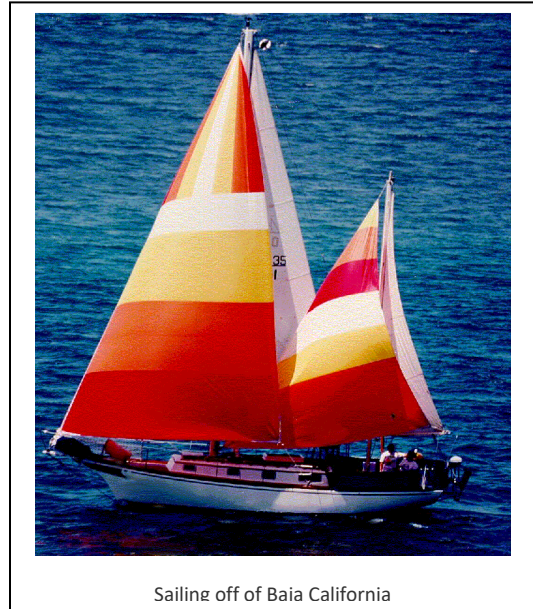
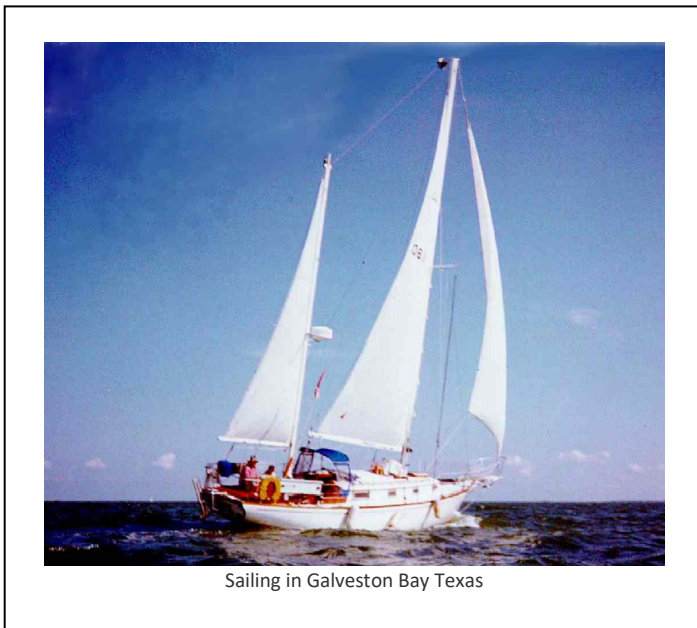
I had a fantastic time sailing Swallow but after the purchase I discovered that age was catching up with her also. Previous owners had delayed some maintenance of minor issues which were now becoming major issues. The most significant were water leakage thru cracks and holes in the fiberglass skin on the cabin top and deck. This leakage was causing rot in the underlying mahogany plywood. Also, hull blisters on her underwater surfaces were beginning to show up.

I recruited some of my friends and replaced the foredeck and side decks where the bulk of the soft spots were located. I continued sailing until I decided it was time for another bottom paint job to be done in the summer of 2005. After thinking about it I decided to rent a covered storage unit, move her into storage and do a

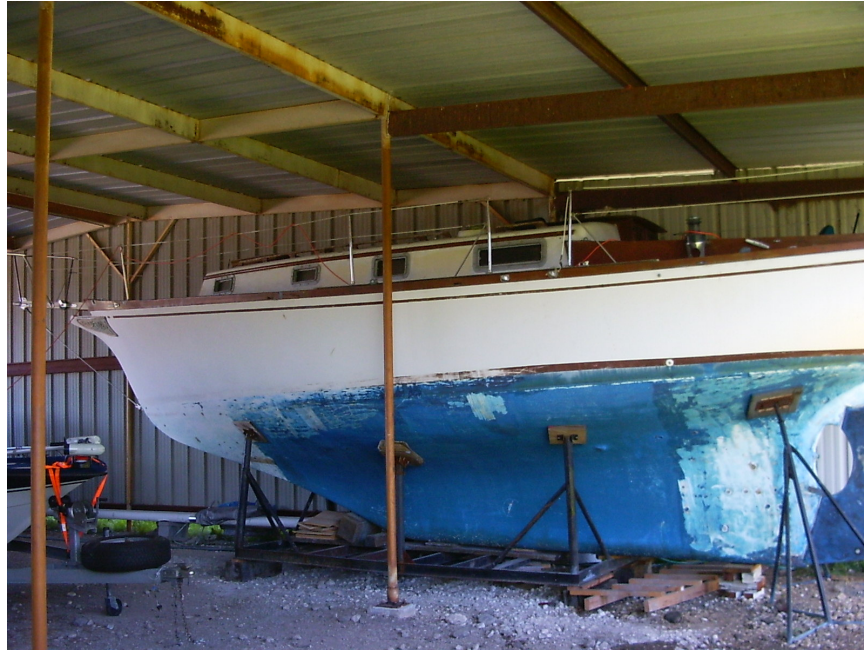
Side view before removing old bottom paint

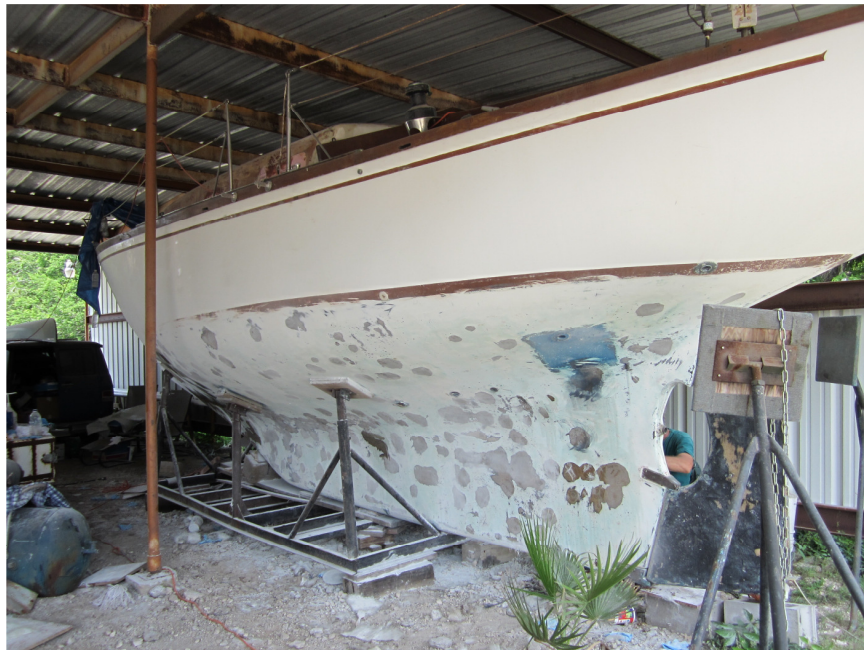
Side view showing repaired blisters

proper blister repair job on the bottom by grinding the blisters out and then allowing the bottom to properly dry out before refilling them.

Swallow was hauled from the water in July 2005 and placed under cover in storage area. Assorted blistering of the bottom was ground out and the hull was allowed to dry out for an extended period of time. The fiberglass on the cabin top was removed in a couple of areas to repair what was thought to be minor rot due to water penetration. I then made the decision to totally strip the cabin top and sides of all gear, remove all the fiberglass and place new plywood over 75% of the cabin top. The cabin top was then re-fiber glassed using DBM-1708 stitch mat and epoxy resin. DBM-1708 is OC Double Bias Fabric stitched to a chopped strand mat offer superior structural performance. 6 Oz fiberglass cloth was then laid over top of the DBM-1708 to provide a smooth finish.

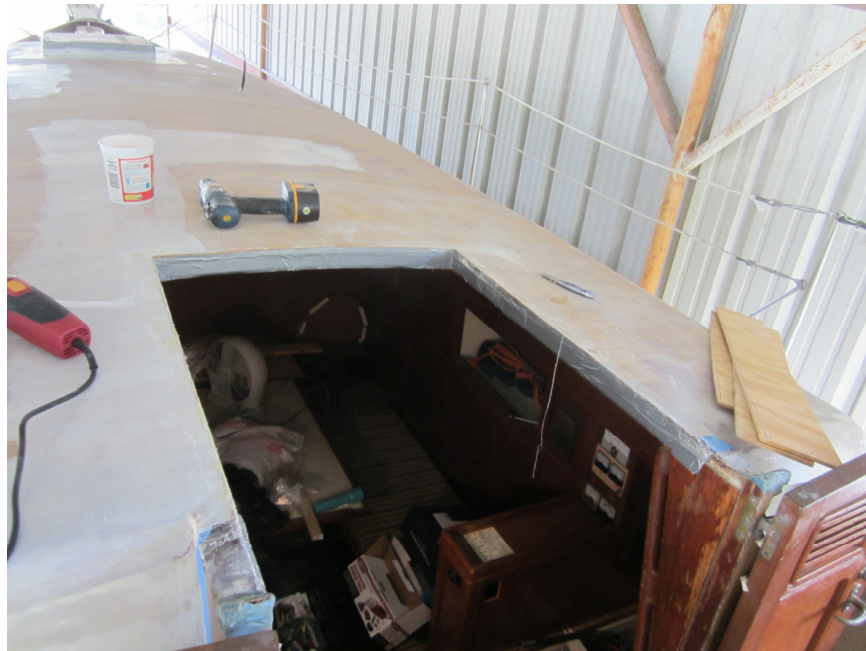
Fiberglass of cabin top in progress

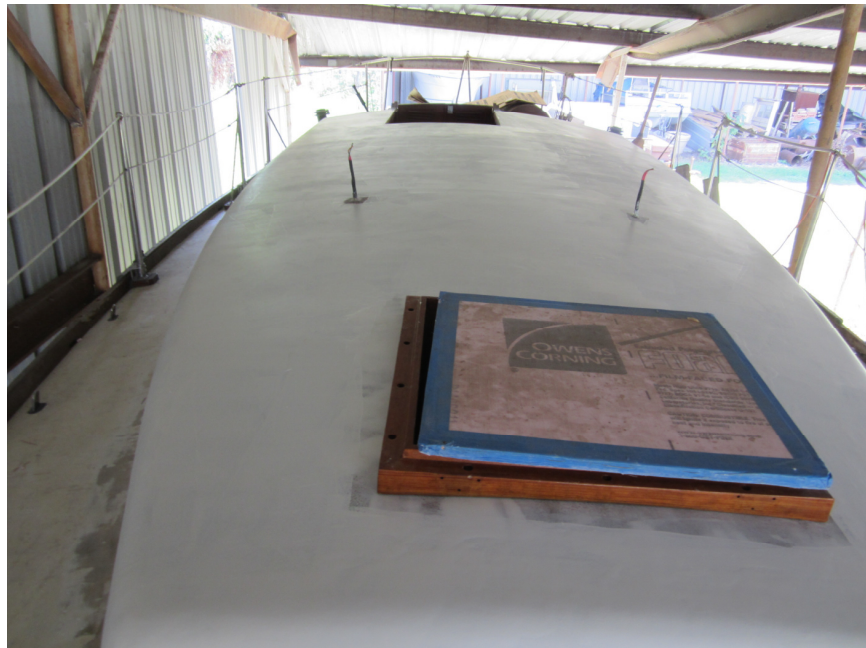
Cabin top after new fiberglass installed and in process of being sanded smooth for painting

The cabin top needs to have a final finish sanding job and then a primer coat and paint applied. After paint, apply a nonskid paint job using granules in the final paint.
